CONCEPTUAL SITE MODEL

Hess Corporation – Former Port Reading Complex (HC-PR)

750 Cliff Road, Port Reading, Middlesex County, New Jersey

March 2021

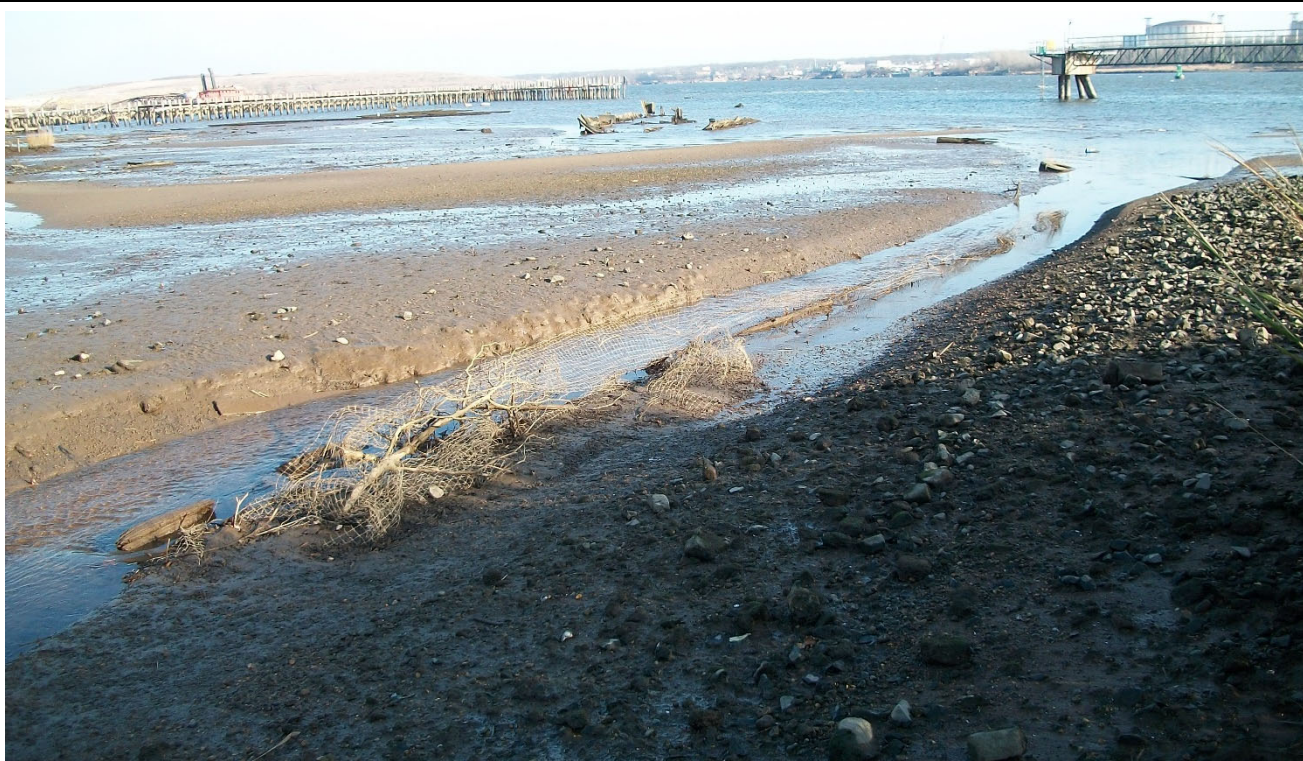
Photo 1: Confluence of the North Drainage Ditch tributary and Arthur Kill.
